## A Closer Look at the WA8LMF TNC Test CD

John Langner, WB2OSZ

Rough Draft 1, January 2016

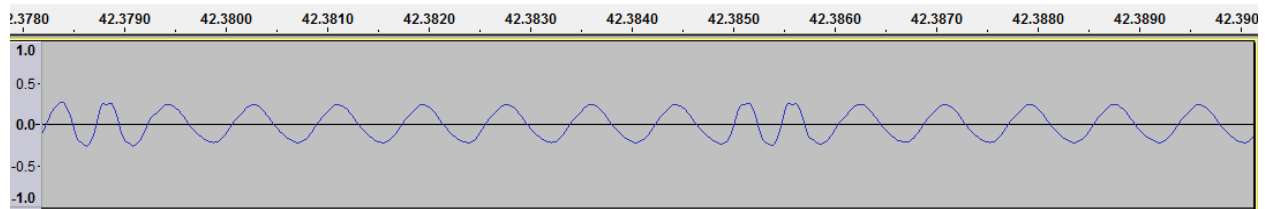
Let's start off with a good looking signal. It looks like a sine wave with a nice rounded shape and you can see how it is shifting between two different tones. Notice how "atest" prints a timestamp from the end of the frame so we can match it up with the audio waveform plot.

```
DECODED[37] 0:42.3903 Digipeater N6EX-1 audio level = 53(24/28)  |||||__
```

Both tones have about the same amplitude so there seems to be no pre-emphasis on the transmitting side. Notice how the amplitudes 24 & 28 are not that much different.

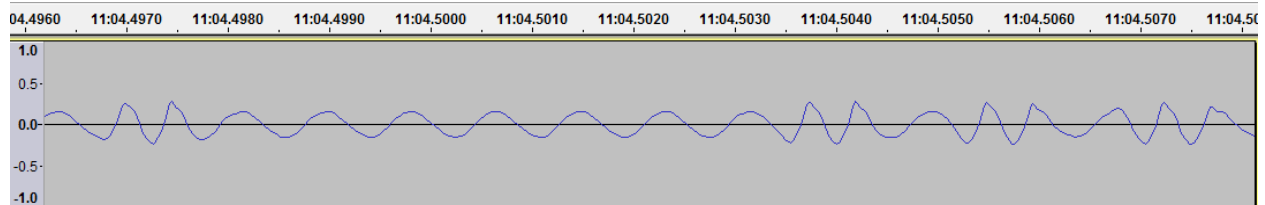
Here you can see how the higher frequency has significantly larger amplitude and looks pointier rather than rounded. This is probably due to pre-emphasis in the transmitter.

```
DECODED[459] 11:04.5089 Digipeater N6EX-4 audio level = 51(17/24)  |||||__
```

There is a larger difference between 17 & 24 here indicating that the higher tone has significantly larger amplitude.

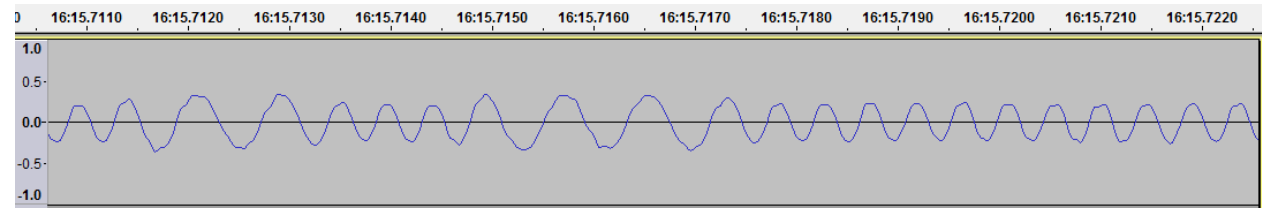
This one was surprising. I would expect to see either constant amplitude or larger amplitude for the higher tone due to pre-emphasis. Instead we see that the higher audio tone is significantly weaker.

DECODED[651] 16:15.7285 KE6RYZ audio level = 68(33/26) \_|||||\_

Notice how the decoder bars are shifted to the right because we have more success when boosting the higher tone.

Maybe the TNC has overly aggressive low pass filtering on the audio output.

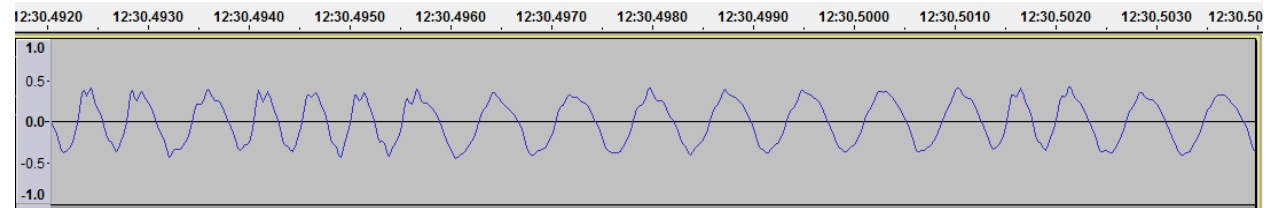
This signal has deviation set a little too high. The peaks are flattened or jagged.

DECODED[514] 12:31.9037 Digipeater WB6JAR-10 audio level = 82(36/34) |||||\_\_

Notice how the audio level is around 80 when the others were around 50.

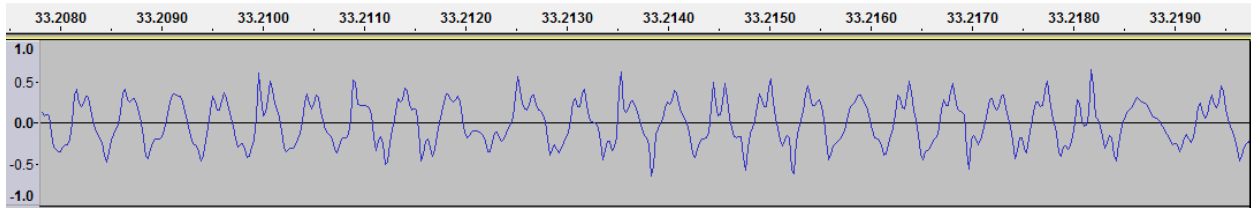
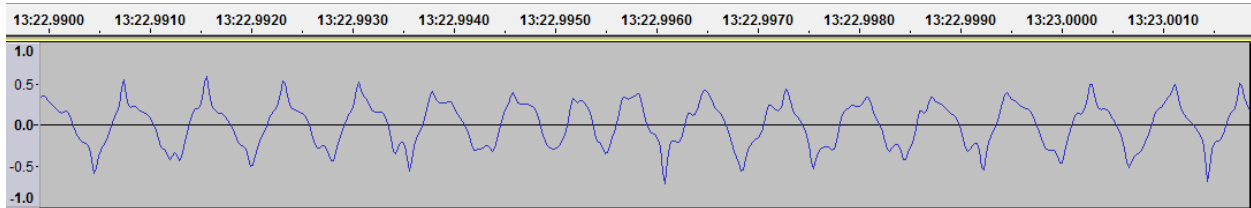
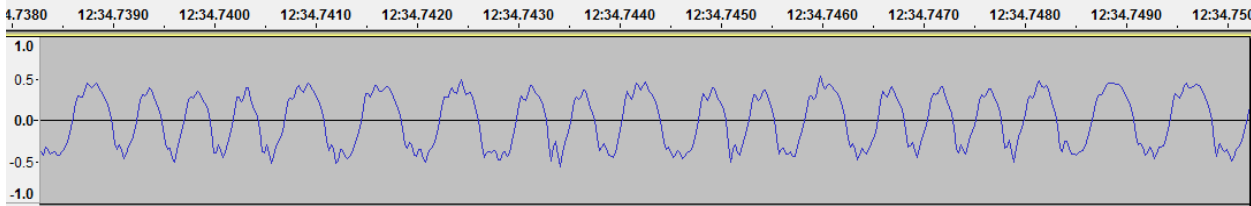
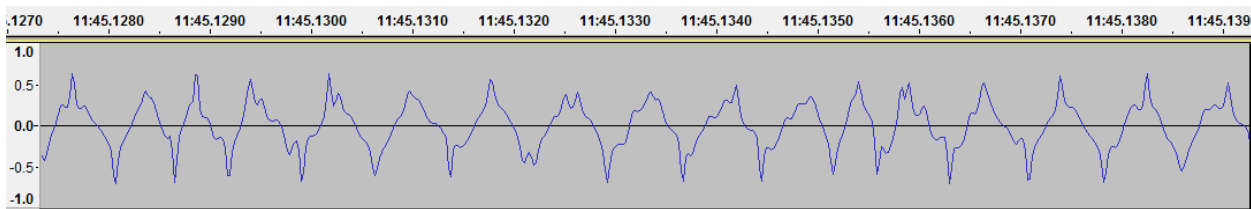
Here are some more extreme cases of over deviation. Notice how the reported level is around 100 or more.

DECODED[27] 0:33.1973 KD6EDM audio level = 116(26/37) \_|||\_\_\_\_\_

DECODED[548] 13:23.0003 Digipeater WIDE2 audio level = 121(37/38) |||||||\_\_

DECODED[516] 12:34.7718 Digipeater RELAY audio level = 96(45/38) |||||||\_\_

DECODED[491] 11:45.1337 Digipeater WB6JAR-10 audio level = 130(37/38) |||||||\_\_

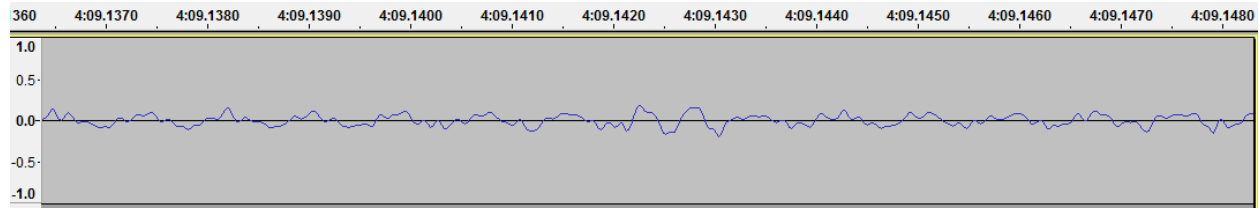
Not sure what's happening here. A small region has larger amplitude than the rest. Remarkably we extract something from it. Barely, as indicated by the one bar.

DECODED[189] 4:09.1476 W6OFR audio level = 61(15/18) |\_\_\_\_\_

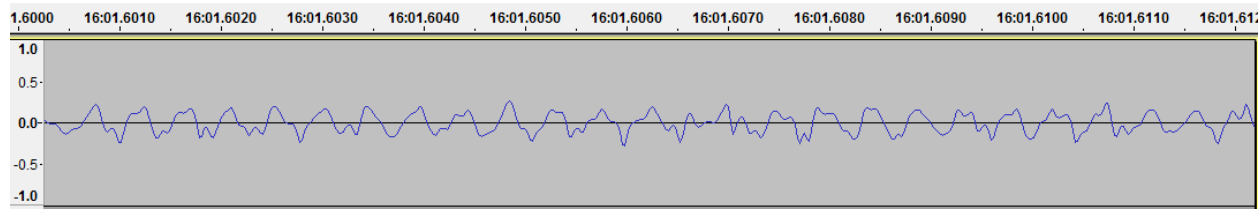
Other signals, from the same station, look very strange. With dips in many of the peaks even though it is not over deviated.

DECODED[646] 16:01.6117 W6OFR audio level = 60(15/18) ||||\_\_\_\_\_

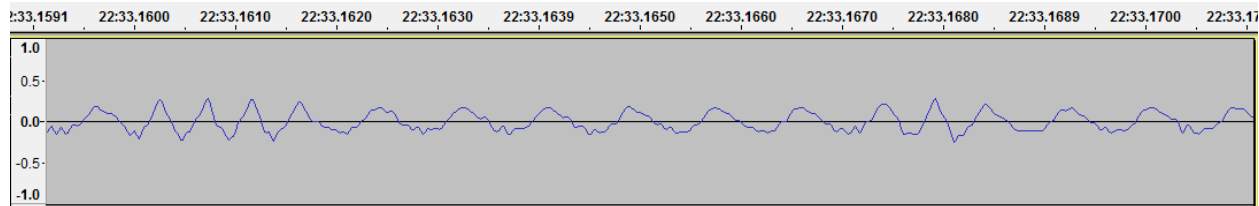
This has ripple with a very interesting pattern. It's not jagged peaks due to over deviation.

DECODED[889] 22:33.1728 Digipeater W6SCE-10 audio level = 53(15/21) \_\_\_\_|\_\_\_\_\_

It looks like a higher frequency component in there. It's not symmetrical but rather mostly on one half of the lower tone. It's not an ephemeral anomaly; we see the same thing in other frames from the same station.

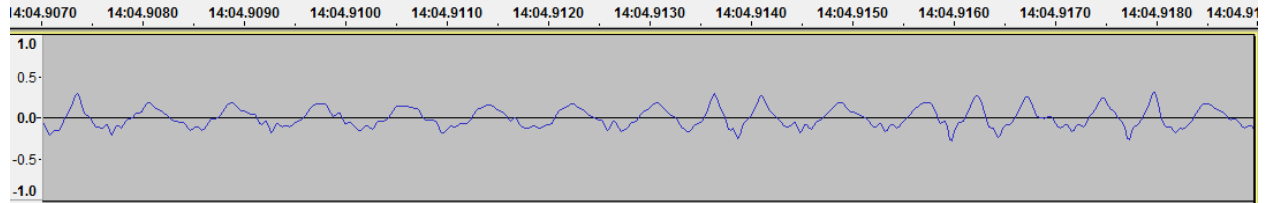
DECODED[576] 14:04.9187 W6SCE-10 audio level = 54(15/22) |||||\_\_\_\_

This looks like a more extreme case of the same thing. Dire Wolf 1.2 was not able to decode it.

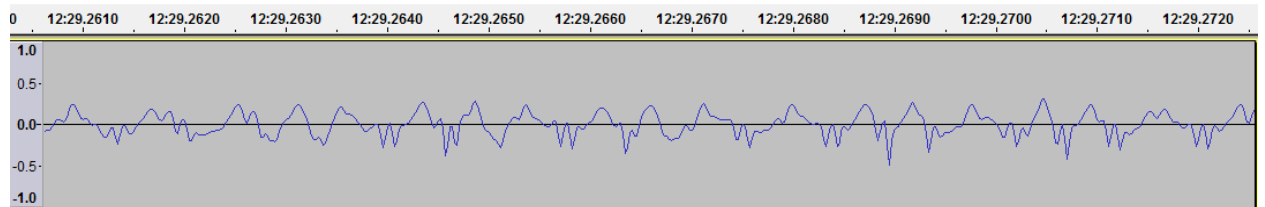
With experimental improvements in Dire Wolf version 1.3, we get this:

DECODED[527] 12:29.3449 Digipeater W6SCE-10 audio level = 96(21/24) [NONE]

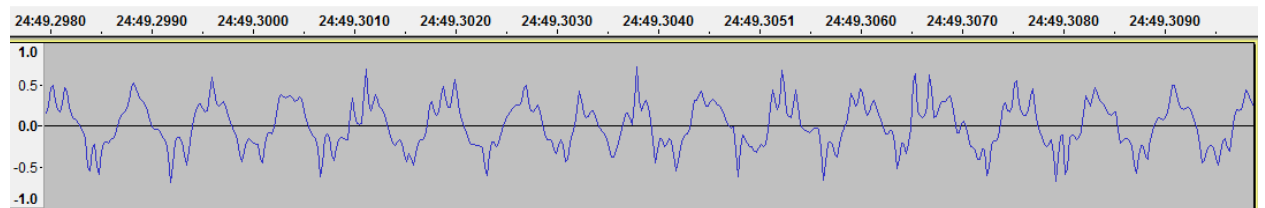
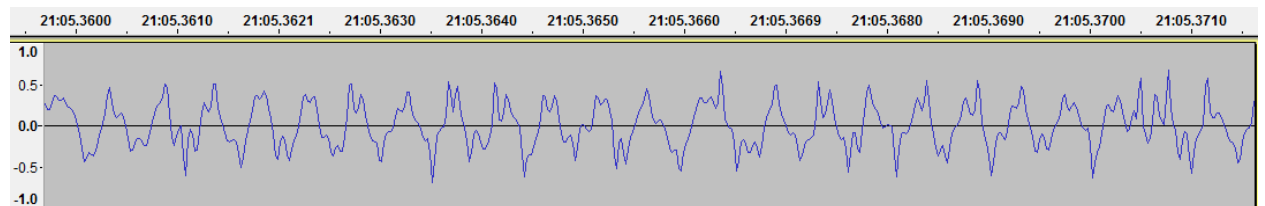
This is interesting, and not in a good way.

DECODED[979] 24:49.3084 KF6KOI audio level = 129(37/32) \_||||\_\_\_\_

DECODED[835] 21:05.3712 KF6KOI audio level = 129(38/33) \_\_\_||\_\_\_

The deviation is too high but there is something else interesting going on there even when we are not near the jagged peaks. I'm wondering if the waveform was generated by pulse width modulation and inadequate filtering.

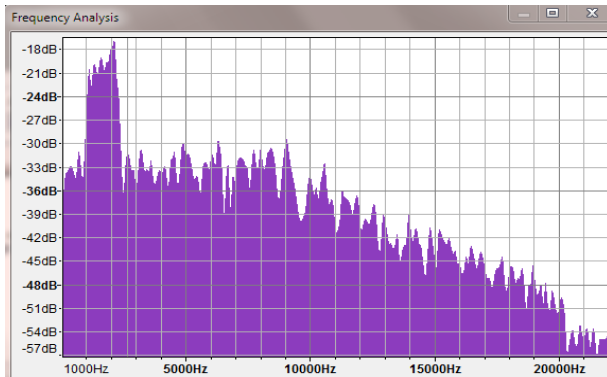
This is what we get from a frequency analysis.

On left side (splatter):

In the most recent example we see many higher frequencies. Here we have multiple spurs out to 9 kHz only 12 dB down from the peak at 2200 Hz.

Unfortunately, the automatic vertical scaling is not adjustable and the two plots have different scales. After making screen captures, and pasting them here, the images have been shifted and stretched in an attempt to make the scales line up.

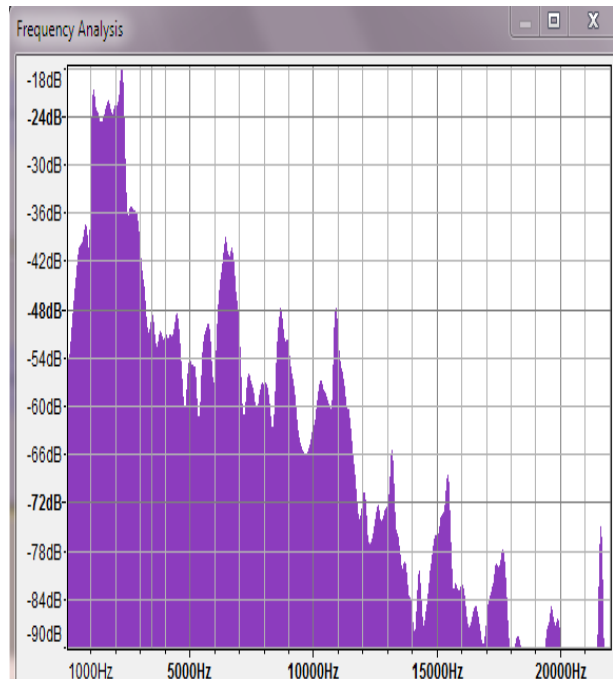
Contrast it with the very first example.

On right side (good signal):

We expect to find peaks around 1200 and 2200 Hz. It should fall off pretty quickly outside of that range. The next major peak is around 6.4 kHz, down about 21 dB from the desired signal.
